**Flood Control Project Maintenance  
Levee Inspections**

## Maintenance Issue Types Only, Levee Inspection Report By Mile - Spring 2017

### Reclamation District No. 0010 Honcut

Waterway	Bank	Unit Miles	Inspection Start/End	Inspector
Unit No. 01 Simmerly Slough	Right	7.65	04/11/2017 04/11/2017	Sterling York

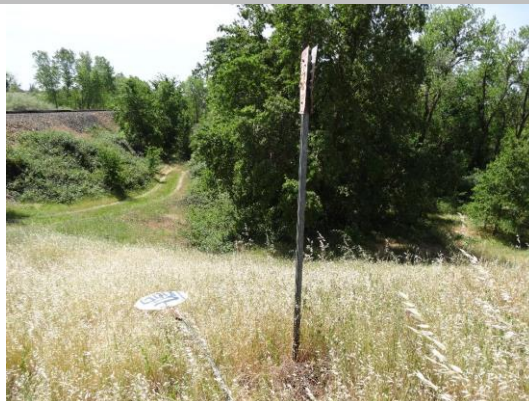
Photo 2 of 3 : UCIP\_SP\_2017\_27791\_51500.jpg

Pipe marker visible on ground--sign has been bent.

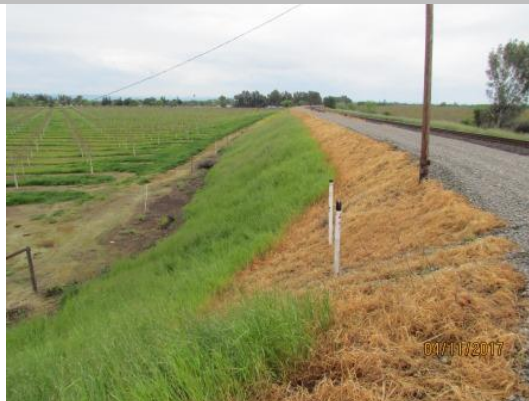
Photo 1 of 1 : SP\_2017\_RD0010\_163\_29\_20170425\_00093.jpg

LM Start	0.00	Rating **	M	Issue No.	29
LM End	1.62	Issue Type +	Ma	Location *	LS
Category	Earthen Levee			GPS Latitude/Longitude	
				Start	End
Item	Vegetation			39.163718 °	39.169305 °
				-121.609935 °	-121.585804 °
DWR ID	DWR_RD0010_01_s_2017_29				
Comment Code					
V1 : Control annual grass and weeds on the levee slopes and easements.					
Inspector Comment					
Annual grass need to be maintained, the shoulder and partial top of slope has been sprayed, Spring 2017.

View looking upstream of the annual grass that need to be maintained, the shoulder and partial top of slope has been sprayed, Spring 2017.

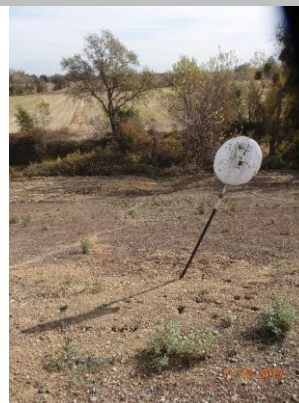
Photo 1 of 3 : UCIP\_SP\_2017\_27748\_51453.jpg

View of waterward side--slope and marker for pipe crossing.

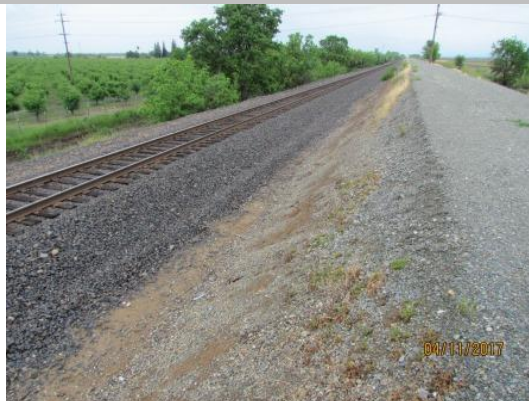
Photo 1 of 1 : SP\_2017\_RD0010\_163\_35\_20170425\_00097.jpg

View of well maintained annual grasses on the landside, Spring 2017.

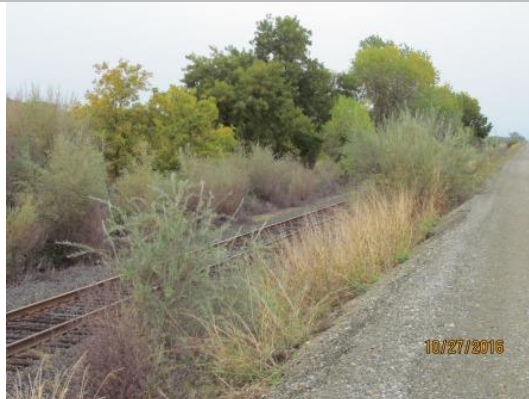
Photo 1 of 1 : SP\_2017\_RD0010\_163\_55\_20170316\_00024.jpg

LM Start	3.01	Rating **	M	Issue No.	55
LM End	3.01	Issue Type +	Ma	Location *	LS
Category	Earthen Levee			GPS Latitude/Longitude	
				Start	End
Item	Trim / Thin Trees			39.189497 °	39.189497 °
				-121.583308 °	-121.583308 °
DWR ID	DWR_RD0010_01_s_2016_55				
Comment Code					
T3 : Trim and thin trees to allow visibility of the ground and room to flood fight.					
Inspector Comment					
Small willow tree on landside slope should be removed. Fall 2016.

View of small willow trees on the landside slope looking upstream. Fall 2016.

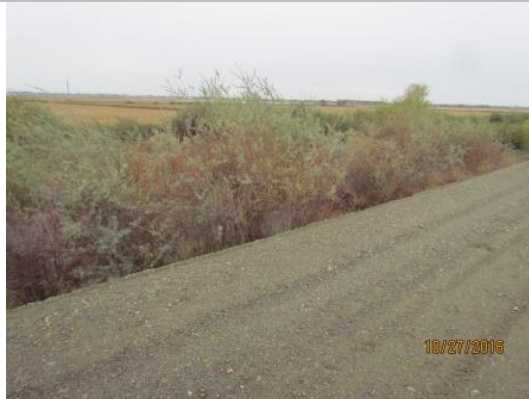
Photo 1 of 1 : SP\_2017\_RD0010\_163\_49\_20170316\_00019.jpg

LM Start	3.93	Rating **	M	Issue No.	49
LM End	3.93	Issue Type +	Ma	Location *	WS
Category	Earthen Levee			GPS Latitude/Longitude	
				Start	End
Item	Trim / Thin Trees			39.202570 °	39.202570 °
				-121.581681 °	-121.581681 °
DWR ID	DWR_RD0010_01_s_2016_49				
Comment Code					
T2 : Thin trees to allow visibility of the ground and room to flood fight.					
Inspector Comment					
Remove small willow trees from levee slope. Fall 2016.

View of small starter willow trees on the landside looking upstream. Fall 2016.

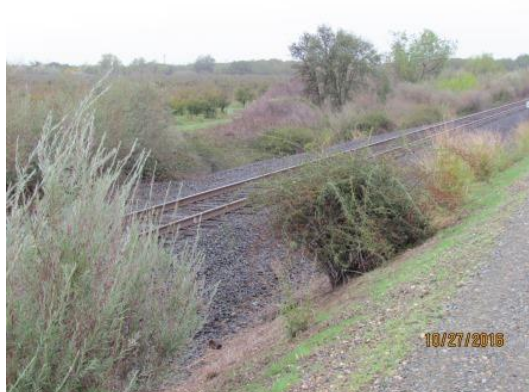
Photo 1 of 1 : SP\_2017\_RD0010\_163\_45\_20170316\_00014.jpg

LM Start	4.84	Rating **	M	Issue No.	45
LM End	4.84	Issue Type +	Ma	Location *	LS
Category	Earthen Levee			GPS Latitude/Longitude	
				Start	End
Item	Vegetation			39.215748 °	39.215748 °
				-121.580032 °	-121.580032 °
DWR ID	DWR_RD0010_01_s_2016_45				
Comment Code					
V2 : Remove the wild growth other than native grasses from the levee slopes.					
Inspector Comment					
Wild Rosebush on landside slope needs to be removed.

View of wild rosebush on the landside levee slope looking upstream. Fall 2016.

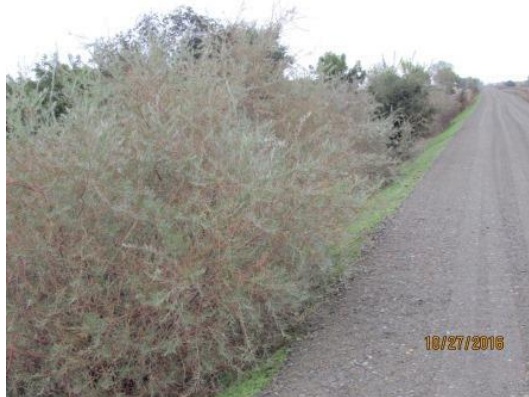
Photo 1 of 1 : SP\_2017\_RD0010\_163\_40\_20170316\_00011.jpg

LM Start	5.47	Rating **	M	Issue No.	40
LM End	5.64	Issue Type +	Ma	Location *	LS
Category	Earthen Levee			GPS Latitude/Longitude	
				Start	End
Item	Trim / Thin Trees			39.224774 °	39.227168 °
				-121.578910 °	-121.578615 °
DWR ID	DWR_RD0010_01_s_2016_40				
Comment Code					
T1 : Trim trees to at least five feet above ground level.					
Inspector Comment					
Remove small willow trees from levee slope. Fall 2016.

View of willow trees on the landside slope looking upstream. Fall 2016.

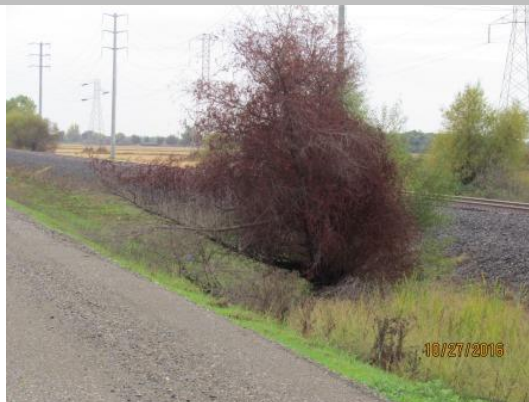
Photo 2 of 2 : SP\_2017\_RD0010\_163\_32\_20170316\_00006.jpg

View of a tree that needs to be removed on the landside, looking downstream. Fall 2016.

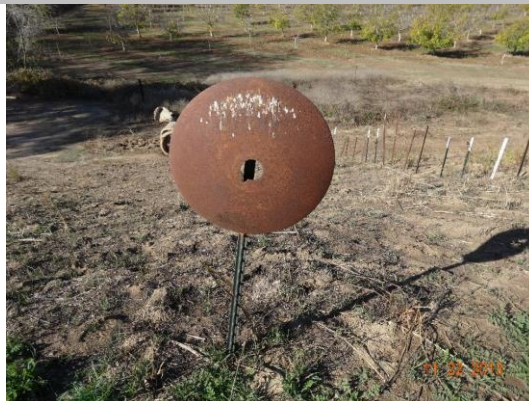
Photo 1 of 3 : UCIP\_SP\_2017\_24824\_44658.jpg

Marker visible on waterward side.

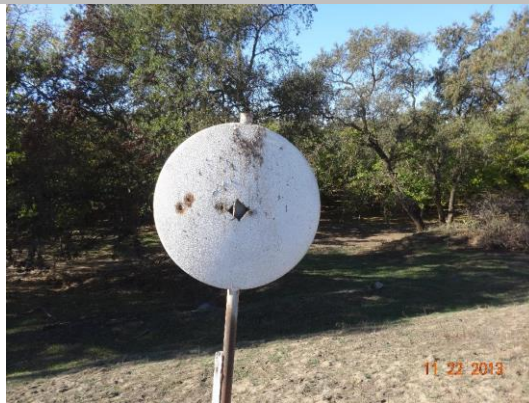
Photo 1 of 3 : UCIP\_SP\_2017\_24826\_44669.jpg

View of marker located on waterward shoulder, no reference number is visible.

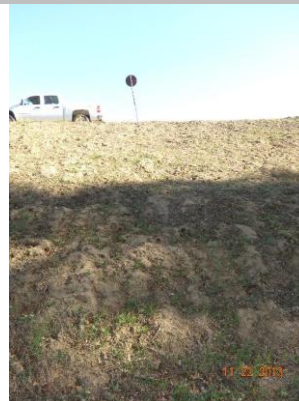
Photo 2 of 3 : UCIP\_SP\_2017\_24826\_44668.jpg

View of waterward slope.

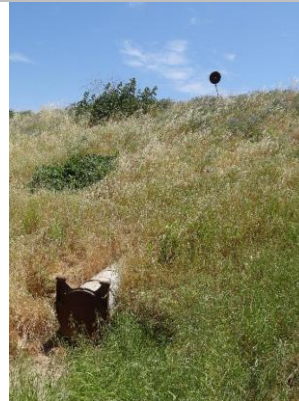
Photo 1 of 3 : UCIP\_SP\_2017\_24751\_44375.jpg

View of waterward side--dense vegetation on slope.

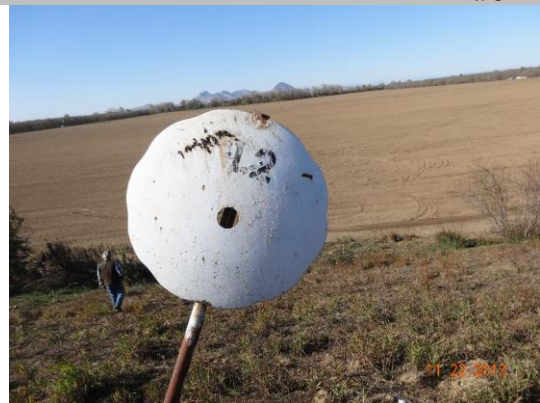
Photo 1 of 3 : UCIP\_SP\_2017\_24828\_44680.jpg

View of marker located on waterward shoulder--crossing referenced as No. 12.

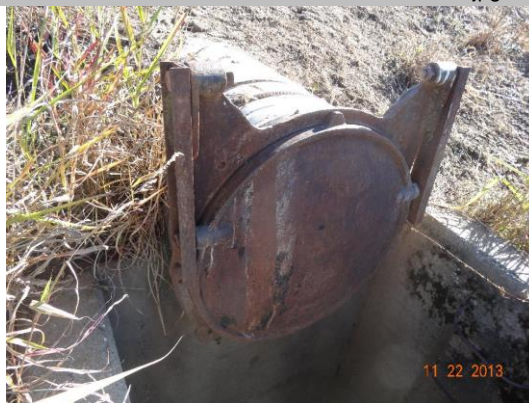
Photo 2 of 3 : UCIP\_SP\_2017\_24828\_44684.jpg

View of flap gate located on waterward side.

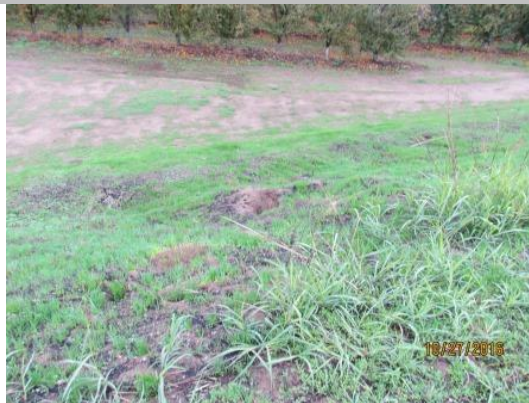
Photo 1 of 1 : SP\_2017\_RD0010\_164\_50\_20170316\_00021.jpg

LM Start	5.20	Rating **	M	Issue No.	50
LM End	5.20	Issue Type +	Ma	Location *	LS
Category	Earthen Levee			GPS Latitude/Longitude	
				Start	End
Item	Animal Control			39.237272 °	39.237272 °
				-121.615424 °	-121.615424 °
DWR ID	DWR_RD0010_02_f_2016_50				
Comment Code					
A3 : No rodents visible, but rodent burrows visible; need to backfill and compact or grout burrows.					
Inspector Comment					
No rodent activity but holes need to be properly backfilled. Spring 2017.

View of rodent hole on landside slope. Fall 2016.

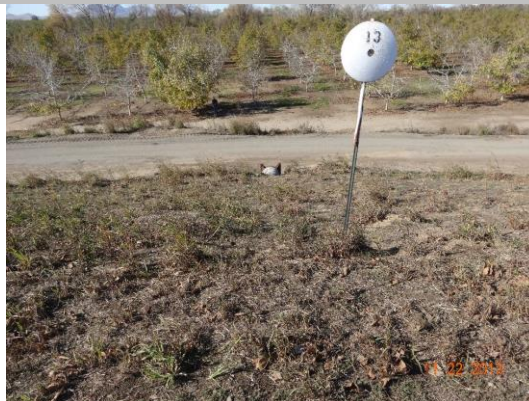
Photo 1 of 3 : UCIP\_SP\_2017\_27793\_51514.jpg

View of marker located on waterward shoulder, pipe is reference as No. 13.

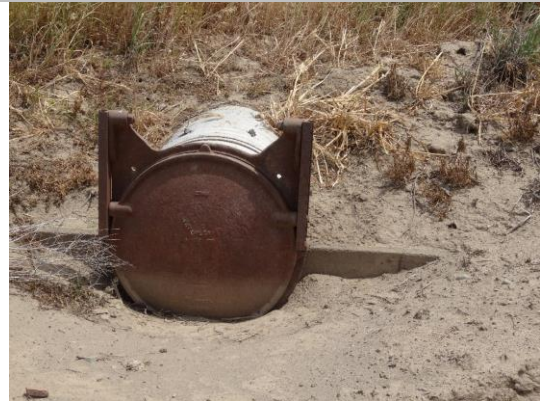
Photo 3 of 3 : UCIP\_SP\_2017\_27793\_51513.jpg

Comment Code					
Inspector Comment					
FS_ID:27793					
DS_ID:21291					
EP_NO: N/A					
Repair Type: Non-Urgent					
Crossing Status: Found					
UCIP Comments: Need to contact owner to remove debris inside concrete distribution box and on slope. This crossing is referenced in the USACE Periodic Inspection as item					
USACE_CESPK_HON2_2013_p_0244.					
FIELD_STRUCT_DESC: 30-inch CM drainpipe through the levee, 17.3 feet below the crown. Two CM cutoff walls around pipe at both shoulders. Flap gate on the waterward end. Slide gate on the landward end. Concrete headwalls at both ends. (USACE-1953). This entry matches the Drainage or Irrigation Structure referenced in O&M manual (Station 413+81).					
FS Date: 4/30/2013

Flap gate and concrete headwall visible on waterward side.

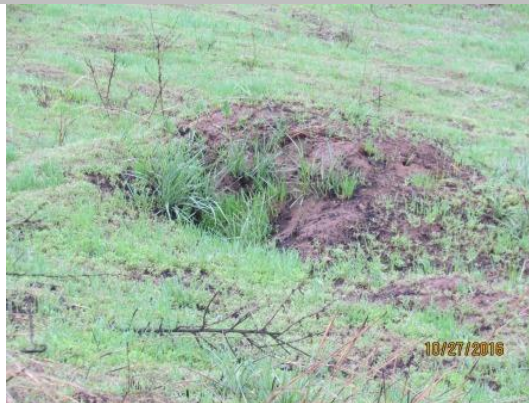
Photo 1 of 1 : SP\_2017\_RD0010\_164\_33\_20170316\_00013.jpg

LM Start	6.88	Rating **	U	Issue No.	33
LM End	6.88	Issue Type +	Ma	Location *	WS
Category	Earthen Levee			GPS Latitude/Longitude	
				Start	End
Item	Animal Control			39.259843 °	39.259843 °
				-121.616013 °	-121.616013 °
DWR ID	DWR_RD0010_02_f_2015_33				
Comment Code					
A3 : No rodents visible, but rodent burrows visible; need to backfill and compact or grout burrows.					
Inspector Comment					
Rodent hole that has more than 2 cubic feet of material, this hole is not active but needs to be backfilled properly.

View of rodent hole that has more than 2 cubic feet of material, this hole is not active but needs to be backfilled properly.

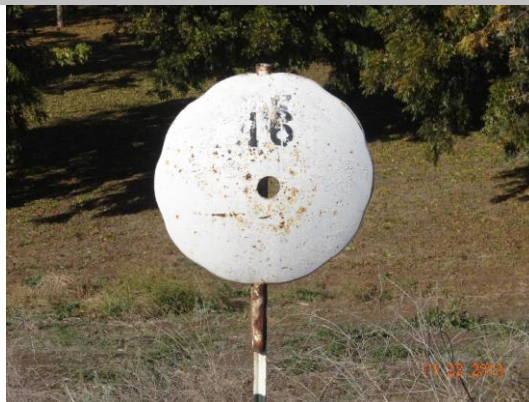
Photo 1 of 3 : UCIP\_SP\_2017\_24832\_44705.jpg

Marker visible on waterward shoulder, crossing is referenced as No. 16.

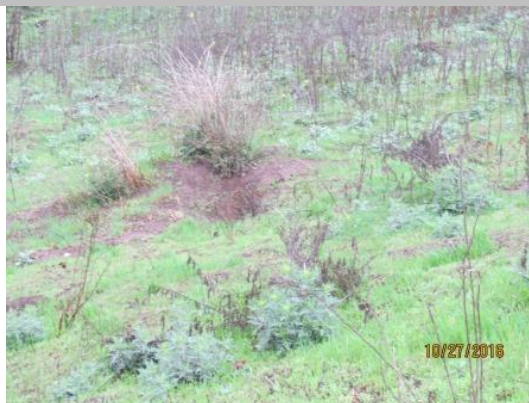
Photo 1 of 1 : SP\_2017\_RD0010\_164\_35\_20170316\_00015.jpg

LM Start	8.09	Rating **	M	Issue No.	35
LM End	8.09	Issue Type +	Ma	Location *	WS
Category	Earthen Levee			GPS Latitude/Longitude	
				Start	End
Item	Animal Control			39.275179 °	39.275179 °
				-121.611283 °	-121.611283 °
DWR ID	DWR_RD0010_02_f_2015_35				
Comment Code					
A3 : No rodents visible, but rodent burrows visible; need to backfill and compact or grout burrows.					
Inspector Comment					
No rodent activity but holes need to be backfilled, Spring 2017.

View of rodent hole on waterside.

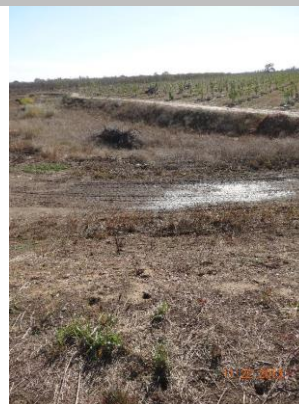
Photo 2 of 3 : UCIP\_SP\_2017\_27775\_51472.jpg

FS\_ID:27775  
DS\_ID:21296  
EP\_NO: N/A  
Repair Type: Non-Urgent  
Crossing Status: Found  
UCIP Comments: Sediment build-up at the inlet--recommend clearing sediment. This crossing is referenced in the USACE Periodic Inspection as item USACE\_CESPK\_HON2\_2013\_p\_0348.  
FIELD\_STRUCT\_DESC: 30-inch CM drainpipe through the levee, 23.0 feet below the crown. Two CM cutoff walls around pipe at both shoulders. Flap gate on the waterward end. Slide gate on the landward end. Concrete headwalls at both ends. Metal marker on waterward shoulder. (USACE-1953). This entry matches the Drainage or Irrigation Structure referenced in O&M manual (Station 551+96).  
FS Date: 4/30/2013

View of landward side.

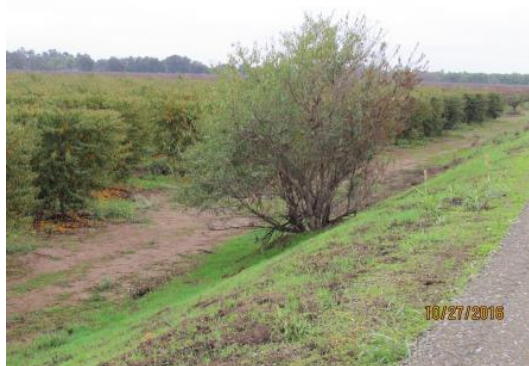
Photo 1 of 1 : SP\_2017\_RD0010\_164\_66\_20170316\_00031.jpg

LM Start	9.02	Rating **	M	Issue No.	66
LM End	9.02	Issue Type +	Ma	Location *	LS
Category	Earthen Levee			GPS Latitude/Longitude	
				Start	End
Item	Trim / Thin Trees			39.282329 °	39.282329 °
				-121.600161 °	-121.600161 °
DWR ID	DWR_RD0010_02_s_2016_66				
Comment Code					
T2 : Thin trees to allow visibility of the ground and room to flood fight.					
Inspector Comment					
Willow tree at toe should be removed.

View of small willow tree on the landside toe looking downstream that should be removed.

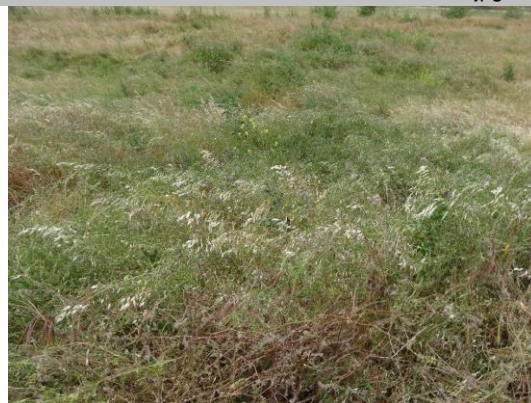
Photo 1 of 3 : UCIP\_SP\_2017\_24768\_44450.jpg

FS\_ID:24768  
DS\_ID:21298  
EP\_NO: N/A  
Repair Type: Non-Urgent  
Crossing Status: Found  
UCIP Comments: Crossing is buried--found indicators of concrete headwall. Need to contact owner to determine status of crossing. This crossing is referenced in the USACE Periodic Inspection as item USACE\_CESPK\_HON2\_2013\_p\_0378.  
FIELD\_STRUCT\_DESC: 24-inch CM drainpipe through the levee, 13.0 feet below the crown. Two CM cutoff walls around pipe at both shoulders. Flap gate on the waterward end. Slide gate on the landward end. Concrete headwalls at both ends. Metal marker on waterward slope. (USACE-1953). This entry matches the Drainage or Irrigation Structure referenced in O&M manual (Station 576+75).  
FS Date: 4/30/2013

View of waterward slope.

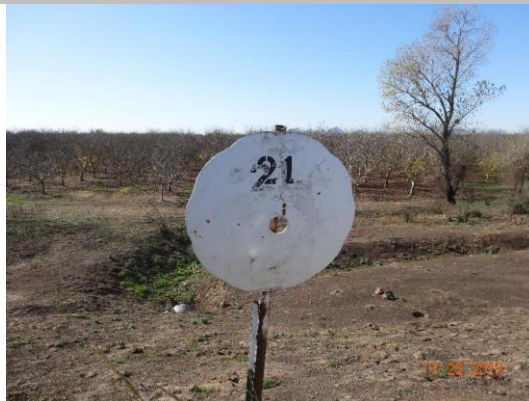
Photo 1 of 3 : UCIP\_SP\_2017\_24835\_44721.jpg

FS\_ID:24835  
DS\_ID:21300  
EP\_NO: N/A  
Repair Type: No Action Needed  
Crossing Status: Found  
UCIP Comments: This crossing is referenced in the USACE Periodic Inspection as item USACE\_CESPK\_HON2\_2013\_p\_0388.  
FIELD\_STRUCT\_DESC: 24-inch CM drainpipe through the levee, 14.0 feet below the crown. Two CM cutoff walls around pipe at both shoulders. Flap gate on the waterward end. Slide gate on the landward side. Concrete headwall, saddle and apron on the waterward end. Metal marker on waterward shoulder. (USACE-1953). This entry matches the Drainage or Irrigation Structure referenced in O&M manual (Station 591+77).  
FS Date: 4/30/2013

Marker visible on waterward shoulder, crossing referenced as No. 21.

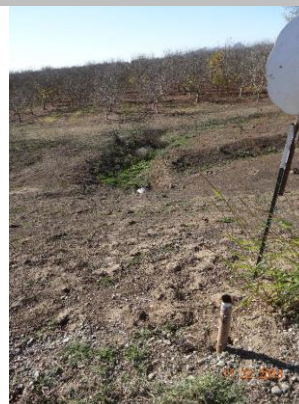
Photo 2 of 3 : UCIP\_SP\_2017\_24835\_44720.jpg

View of waterward side.

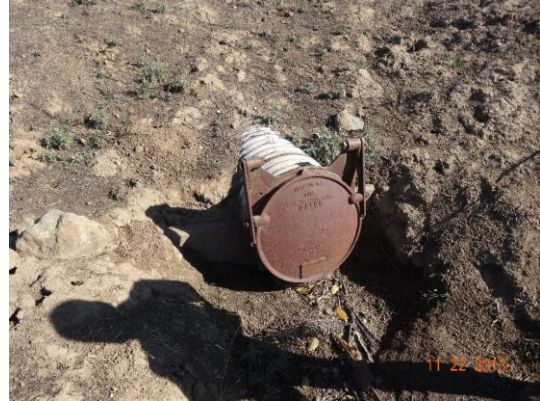
Photo 3 of 3 : UCIP\_SP\_2017\_24835\_44725.jpg

Item	DWR UCIP LMA Responsibility			39.289315 °	39.289315 °	
				-121.601183 °	-121.601183 °	
DWR ID						
Comment Code						
Inspector Comment						
FS_ID:24835						
DS_ID:21300						
EP_NO: N/A						
Repair Type: No Action Needed						
Crossing Status: Found						
UCIP Comments: This crossing is referenced in the USACE Periodic Inspection as item USACE_CESPK_HON2_2013_p_0388.						
FIELD_STRUCT_DESC: 24-inch CM drainpipe through the levee, 14.0 feet below the crown. Two CM cutoff walls around pipe at both shoulders. Flap gate on the waterward end. Slide gate on the landward side. Concrete headwall, saddle and apron on the waterward end. Metal marker on waterward shoulder. (USACE-1953). This entry matches the Drainage or Irrigation Structure referenced in O&M manual (Station 591+77).						
FS Date: 4/30/2013

View of flap gate located on waterward side.

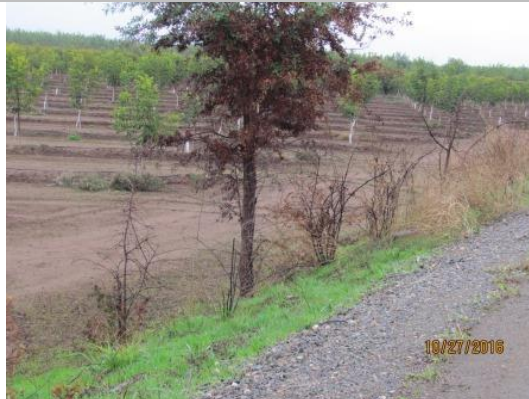
Photo 1 of 1 : SP\_2017\_RD0010\_164\_75\_20170316\_00038.jpg

LM Start	10.48	Rating **	M	Issue No.	75
LM End	10.63	Issue Type +	Ma	Location *	LS
Category	Earthen Levee			GPS Latitude/Longitude	
				Start	End
Item	Trim / Thin Trees			39.298762 °	39.300083 °
				-121.614394 °	-121.616614 °
DWR ID	DWR_RD0010_02_s_2016_75				
Comment Code					
T2 : Thin trees to allow visibility of the ground and room to flood fight.					
Inspector Comment					
Tree has been trimmed up but small starter trees should be removed. Fall 2016.

View of landside looking downstream where the tree has been trimmed up but small starter trees should be removed.

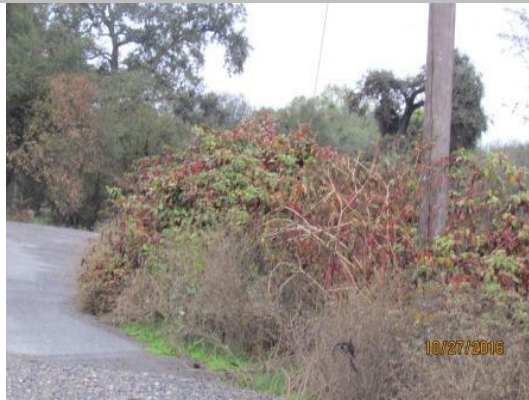
Photo 1 of 1 : SP\_2017\_RD0010\_164\_76\_20170316\_00039.jpg

LM Start	10.70	Rating **	M	Issue No.	76
LM End	10.70	Issue Type +	Ma	Location *	WS
Category	Earthen Levee			GPS Latitude/Longitude	
				Start	End
Item	Vegetation			39.300866 °	39.300866 °
				-121.617510 °	-121.617510 °
DWR ID	DWR_RD0010_02_s_2016_76				
Comment Code					
V4 : Elderberries are blocking visibility and flood fight capability.					
Inspector Comment					
Wild growth on waterside slope should be removed, as appropriate.

View looking downstream at wild growth on waterside slope that needs to be removed.

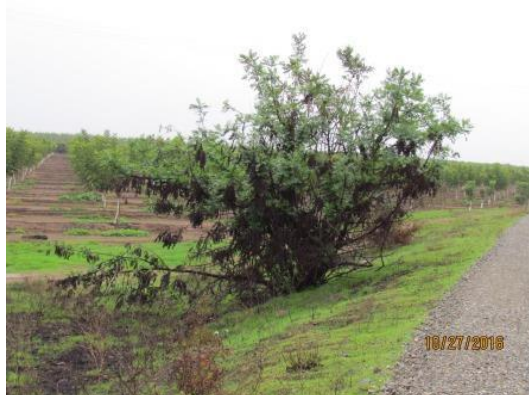
Photo 1 of 1 : SP\_2017\_RD0010\_164\_77\_20170316\_00040.jpg

LM Start	10.79	Rating **	M	Issue No.	77
LM End	10.79	Issue Type +	Ma	Location *	LS
Category	Earthen Levee			GPS Latitude/Longitude	
				Start	End
Item	Trim / Thin Trees			39.302055 °	39.302055 °
				-121.617730 °	-121.617730 °
DWR ID	DWR_RD0010_02_s_2016_77				
Comment Code					
T2 : Thin trees to allow visibility of the ground and room to flood fight.					
Inspector Comment					
Small tree on slope should be removed.

View looking downstream of a small tree on landside slope that should be removed.

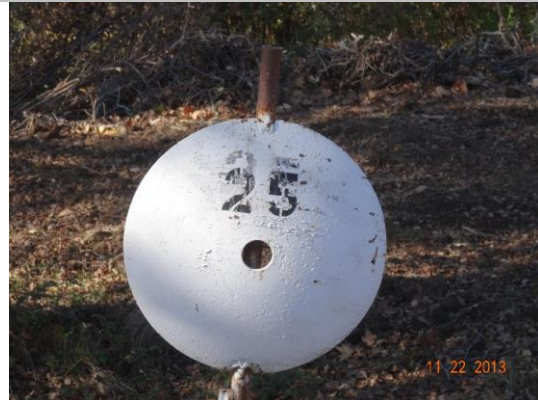
Photo 1 of 3 : UCIP\_SP\_2017\_24840\_44753.jpg

Comment Code					
Inspector Comment					
FS_ID:24840 DS_ID:21305 EP_NO: N/A Repair Type: Non-Urgent Crossing Status: Found UCIP Comments: Burrow activity--large holes found on landward side. Crossing on landward side is blocked. Recommend clearing headwall and crossing. Need to coordinate with owner to determine status of crossing. If crossing is no longer in use owner will need to contact the CVFPB to comply with Title 23. This crossing is referenced in the USACE Periodic Inspection as item USACE_CESPK_HON2_2013_p_0476. FIELD_STRUCT_DESC: 24-inch CM pipe through the levee, 7.5 feet below the crown. Two CM cutoff walls around pipe at both shoulders. Flap gate on the waterward end. Concrete headwall at both toes. Saddle and apron on waterward side. (USACE-1953). This entry matches the Drainage or Irrigation Structure referenced in O&M manual (Station 674+73). FS Date: 4/30/2013

Marker visible on waterward side, crossing is referenced as No. 25.

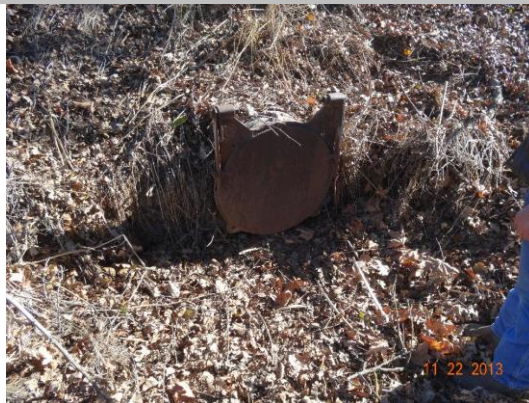
Photo 2 of 3 : UCIP\_SP\_2017\_24840\_44752.jpg

FS\_ID:24840  
DS\_ID:21305  
EP\_NO: N/A  
Repair Type: Non-Urgent  
Crossing Status: Found  
UCIP Comments: Burrow activity--large holes found on landward side. Crossing on landward side is blocked. Recommend clearing headwall and crossing. Need to coordinate with owner to determine status of crossing. If crossing is no longer in use owner will need to contact the CVFPB to comply with Title 23. This crossing is referenced in the USACE Periodic Inspection as item USACE\_CESPK\_HON2\_2013\_p\_0476.  
FIELD\_STRUCT\_DESC: 24-inch CM pipe through the levee, 7.5 feet below the crown. Two CM cutoff walls around pipe at both shoulders. Flap gate on the waterward end. Concrete headwall at both toes. Saddle and apron on waterward side. (USACE-1953). This entry matches the Drainage or Irrigation Structure referenced in O&M manual (Station 674+73).  
FS Date: 4/30/2013

View of flap gate located on waterward side.

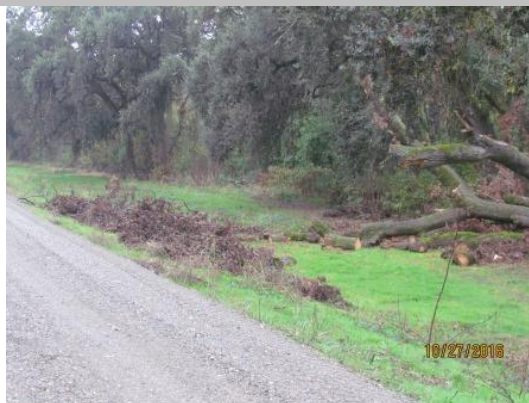
Photo 1 of 1 : SP\_2017\_RD0010\_164\_52\_20170316\_00022.jpg

LM Start	11.15	Rating **	M	Issue No.	52
LM End	11.15	Issue Type +	Ma	Location *	WS
Category	Earthen Levee			GPS Latitude/Longitude	
				Start	End
Item	Trim / Thin Trees			39.307133 °	39.307133 °
				-121.617263 °	-121.617263 °
DWR ID	DWR_RD0010_02_f_2016_52				
Comment Code					
T2 : Thin trees to allow visibility of the ground and room to flood fight.					
Inspector Comment					
Tree fell this fall and the limbs need to be removed from levee slope. Fall 2016.

View of waterside looking downstream where a tree fell this fall and the limbs need to be removed from levee slope. Fall 2016.

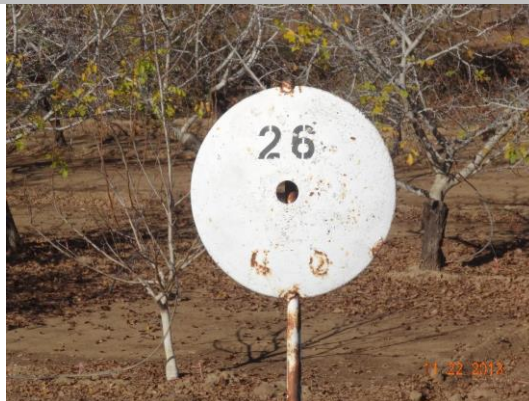
Photo 1 of 3 : UCIP\_SP\_2017\_24842\_44764.jpg

FS\_ID:24842  
DS\_ID:21307  
EP\_NO: N/A  
Repair Type: Non-Urgent  
Crossing Status: Found  
UCIP Comments: Sediment deposit inside pipe--Need to coordinate with owner to determine status of crossing. If crossing is no longer in use owner will need to contact the CVFPB to comply with Title 23.  
FIELD\_STRUCT\_DESC: 24-inch CM drainpipe through the levee, 15.0 feet below the crown. Two CM cutoff walls around pipe at both shoulders. Flap gate on the waterward end. Slide gate on the landward end. Concrete headwall at both toes. (USACE-1953). This entry matches the Drainage or Irrigation Structure referenced in O&M manual (Station 134+06).  
FS Date: 5/1/2013

Marker visible on waterward side--No. 26.

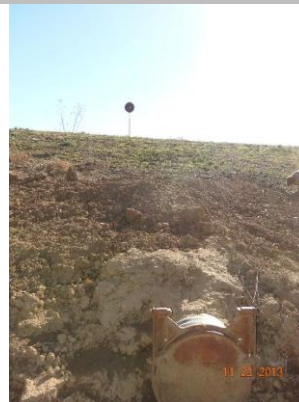
Photo 2 of 3 : UCIP\_SP\_2017\_24842\_44762.jpg

View of waterward slope.

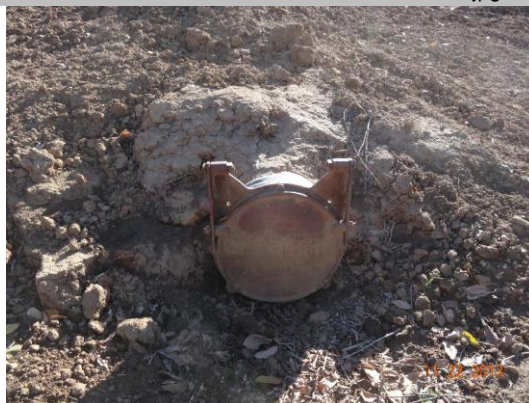
Photo 3 of 3 : UCIP\_SP\_2017\_24842\_44763.jpg

Comment Code					
Inspector Comment					
FS_ID:24842					
DS_ID:21307					
EP_NO: N/A					
Repair Type: Non-Urgent					
Crossing Status: Found					
UCIP Comments: Sediment deposit inside pipe--Need to coordinate with owner to determine status of crossing. If crossing is no longer in use owner will need to contact the CVFPB to comply with Title 23.					
FIELD_STRUCT_DESC: 24-inch CM drainpipe through the levee, 15.0 feet below the crown. Two CM cutoff walls around pipe at both shoulders. Flap gate on the waterward end. Slide gate on the landward end. Concrete headwall at both toes. (USACE-1953). This entry matches the Drainage or Irrigation Structure referenced in O&M manual (Station 134+06).					
FS Date: 5/1/2013

View of flap gate located on waterward side.
